Clackamas River Ranger District
Mt. Hood National Forest
Site Monitor and Addendum

ADDENDING SITE: 663EA27

SITE NAME: **Hawk Mtn. Cabin**TOWNSHIP: 8 SouthRANGE: 7 EastSECTION: 27USGS QUAD: Breitenbush Hot Springs7.5 min. 1997SHPO QUAD: Breitenbush Hot Springs SW15 min. 1982

Hawk Mtn. Cabin Restoration

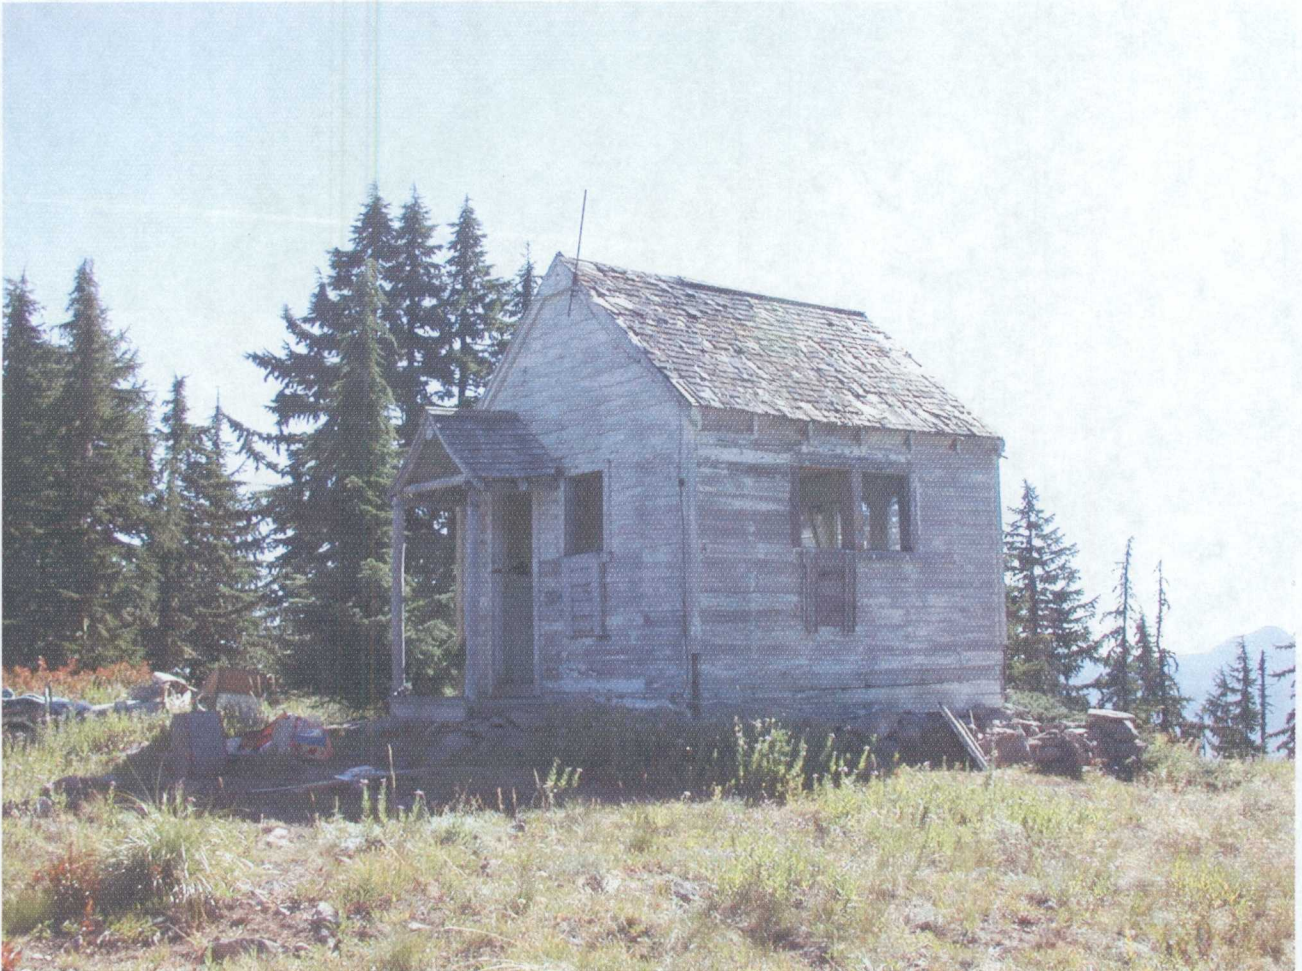
Roof Replacement: The old sawn shingles and roofing nails were removed down to the beveled shiplap 1x5" roofing boards. Short sections of these boards (less than four feet in length) were decayed on the southeast side of the roof due to exposure from missing shingles. Decayed sections were removed and replaced with boards milled earlier in the summer to replicate the original shiplap. The replacement boards were milled to the same dimensions as the original boards but intentionally left 1/16th inch less in width to avoid problems retrofitting them between original roof boards left in place. The newly milled shiplap does not have beveled edges and is not visible in this application. While stripping the roof, the old chimney flashing was also removed.

Cabin and roof prior to restoration

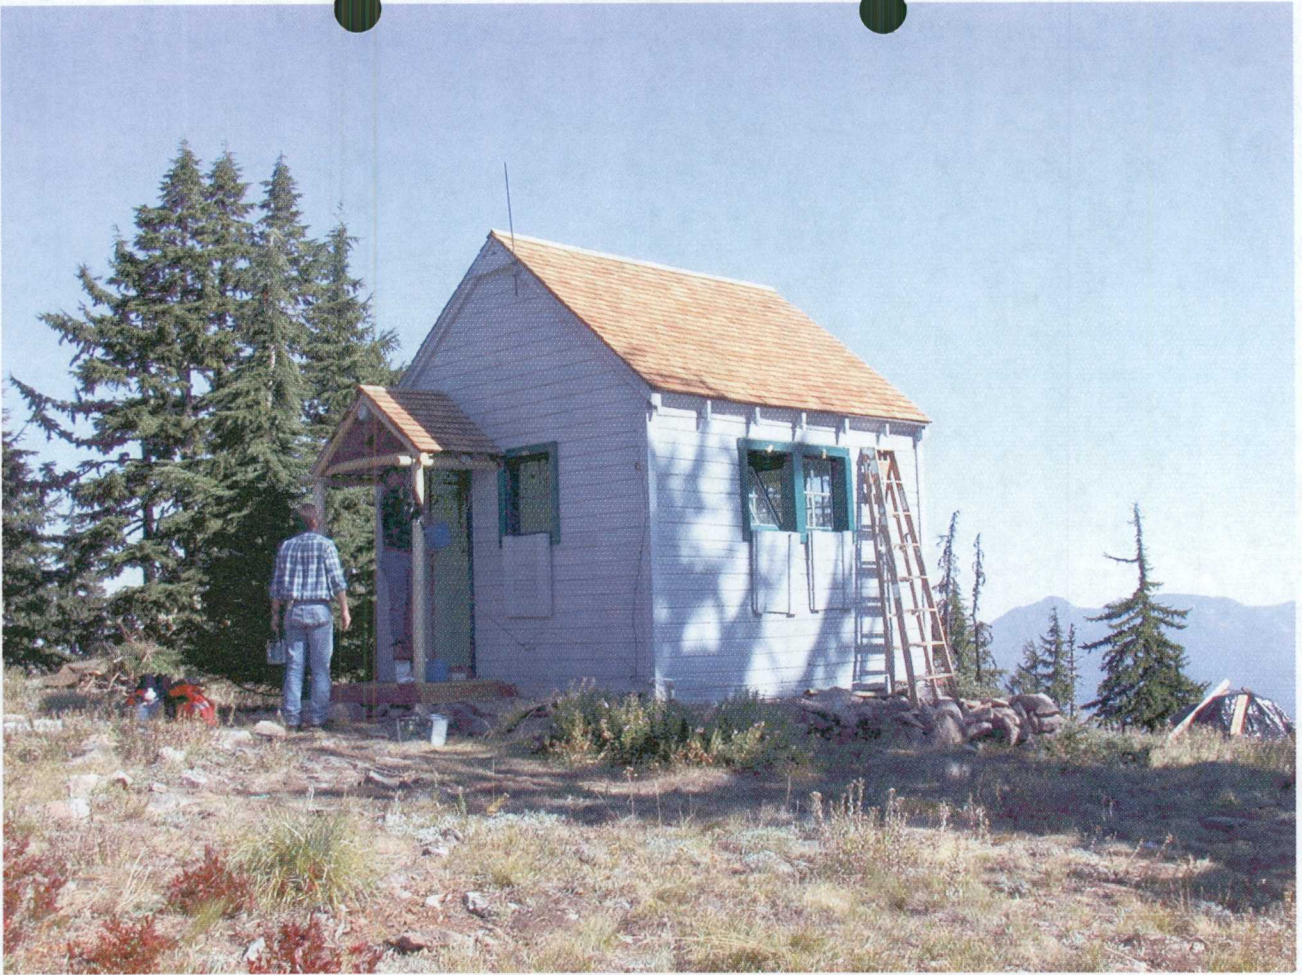
Cabin roof after completion

Following shingle removal and replacement of the decayed boards, 15 pound roofing felt was layed out and fastened to the roof. Once this was complete, installation of the new shingles was started. Almost 3 squares (approximately 15 bundles) of #1 sawn cedar shingles were used for this project due to the 4 inch exposure of each row needed to match the original exposure (normal exposure is about 5 inches which would have required less shingles). After all shingles were installed, two 1x4" cedar boards 12 ½ feet in length were overlapped to form the ridge cap. Roofing activity took two people approximately two days to complete. This includes the time spent replacing roof boards and a short section of one 2x6" decayed rafter and "birdblock" in the extreme southeast corner, and installing the new chimney collar and flashing.

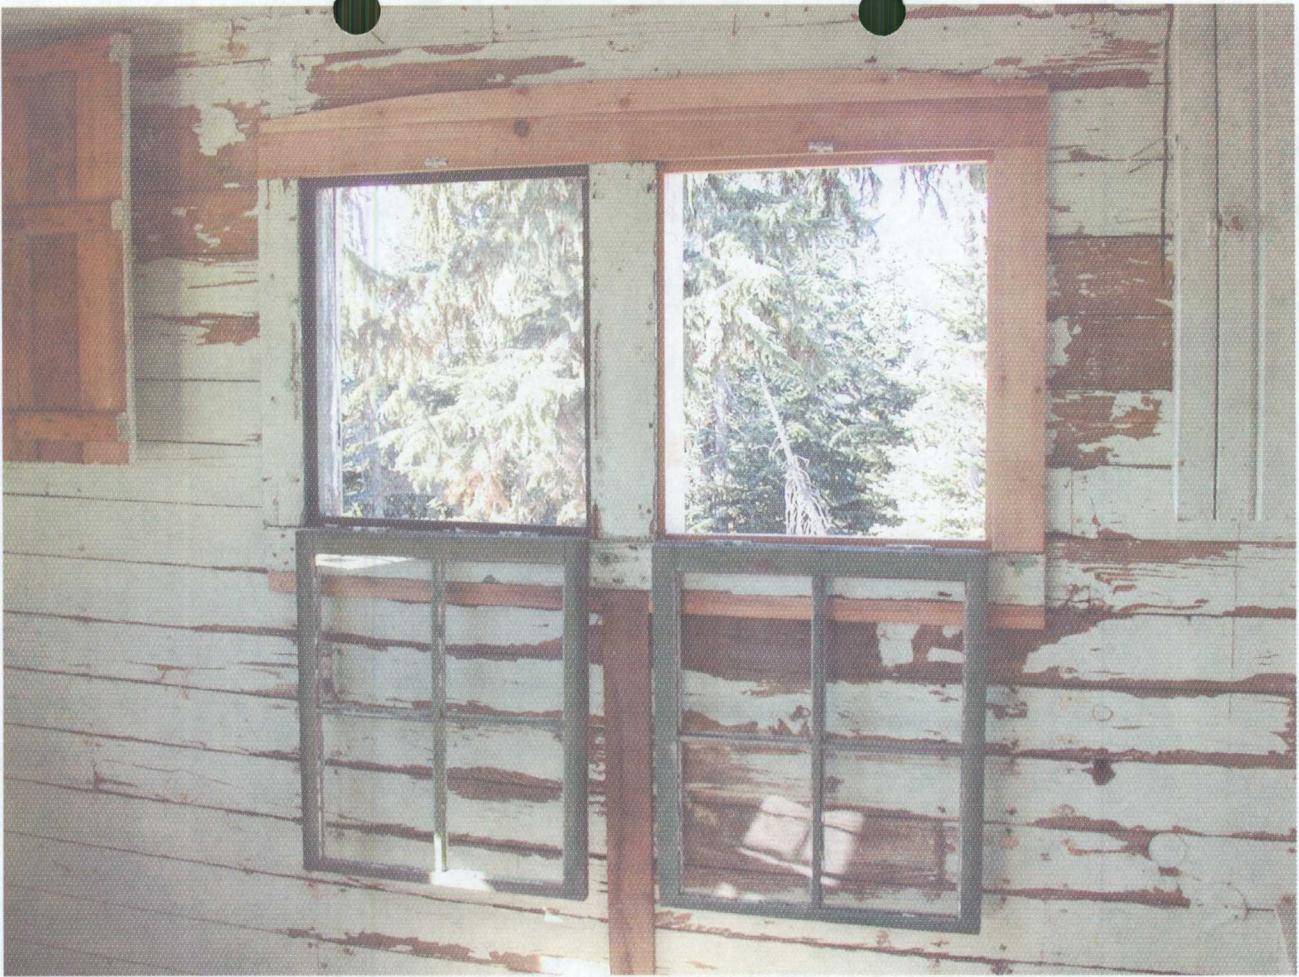
Windows and Interior Trim: The windows on the west side of the building were missing two pieces of interior trim and the northernmost of the two windows was missing the entire window casing along with the exterior mullion between the two windows. The missing pieces had allowed water to penetrate causing deterioration of structural wall members below the window. Removal of loose outside siding below the windows revealed previous structural repairs as was also evident inside where a vertical 1x4" board had been placed below the window trim. Interior wall boards above and below the window were also partially decayed, leaving voids outside the perimeter of the trim. After replacing the missing interior trim boards, the voids were covered by extending the trim pieces below and above the original trim outline. So as not to conflict with the original appearance, the upper trim board extension was cut in the same general pattern as the original board above the south windows. The window casing and mullion were replaced in kind although the window frame has settled through time causing it to be slightly out of square but still sealing the window when closed.

Trim repairs and scraped west wall

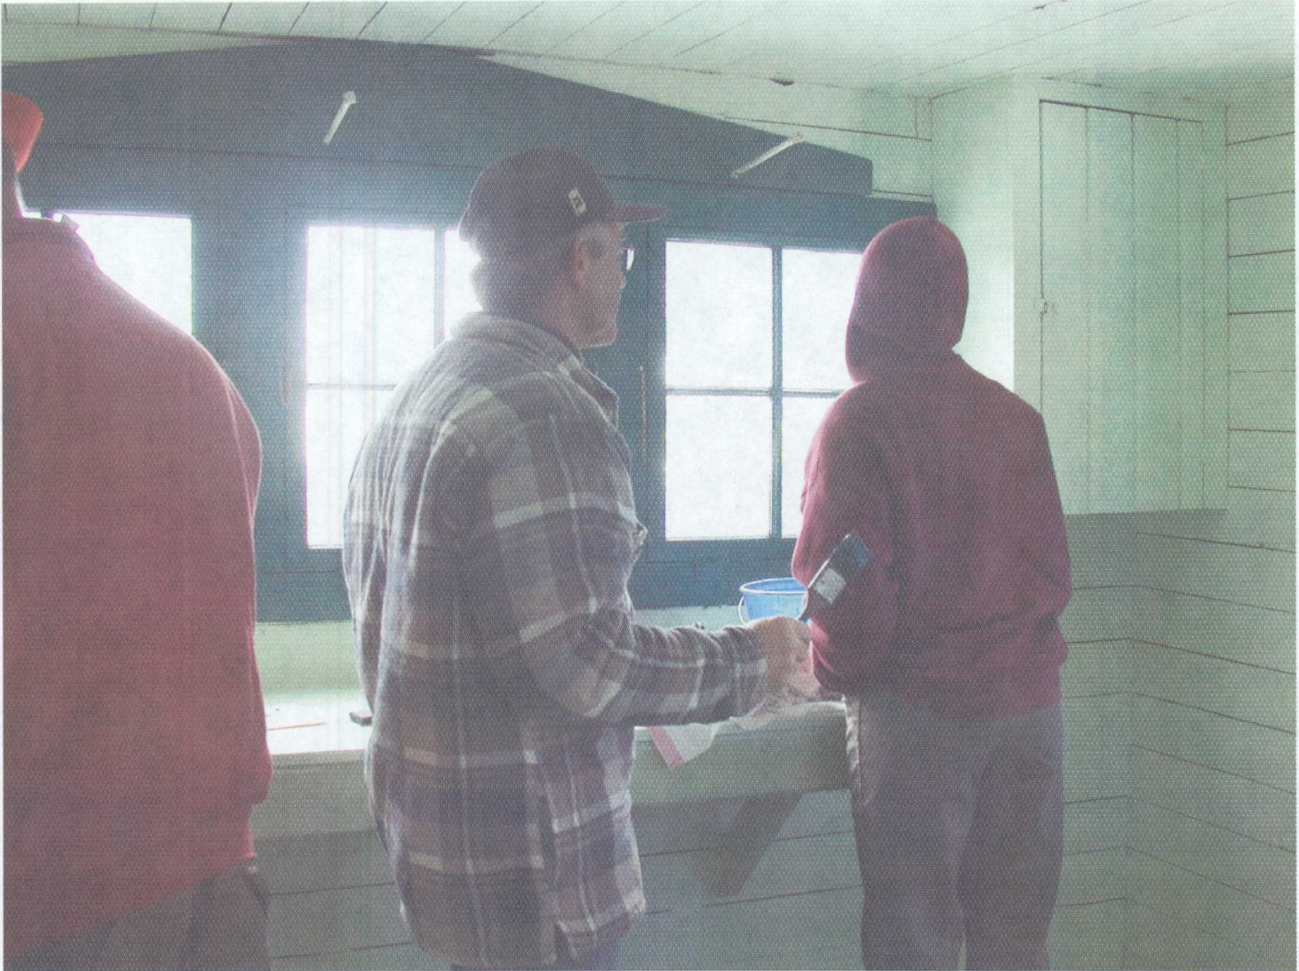
Interior painting

Scraping and painting of the interior first required removal of interior features such as the steel framed single bed, woodbox, and table bench along with other removable artifacts from the cabinets and walls. Once this was completed, numerous nails, tacks, and staples which at one time were used to fasten oilcloth fabric to the countertops and tabletop were removed. It was then possible to begin paint preparations by first scraping, sanding where needed, and then washing down (with water and

a mild detergent) all exposed interior surfaces. Volunteers then began painting the walls, ceiling, cabinets, and table. At the same time, following similar preparation, the woodbox and table bench were also painted (pale green) by volunteers outside. The steel bedframe was painted with rust inhibiting paint in a dark green color matching the interior and exterior trim.

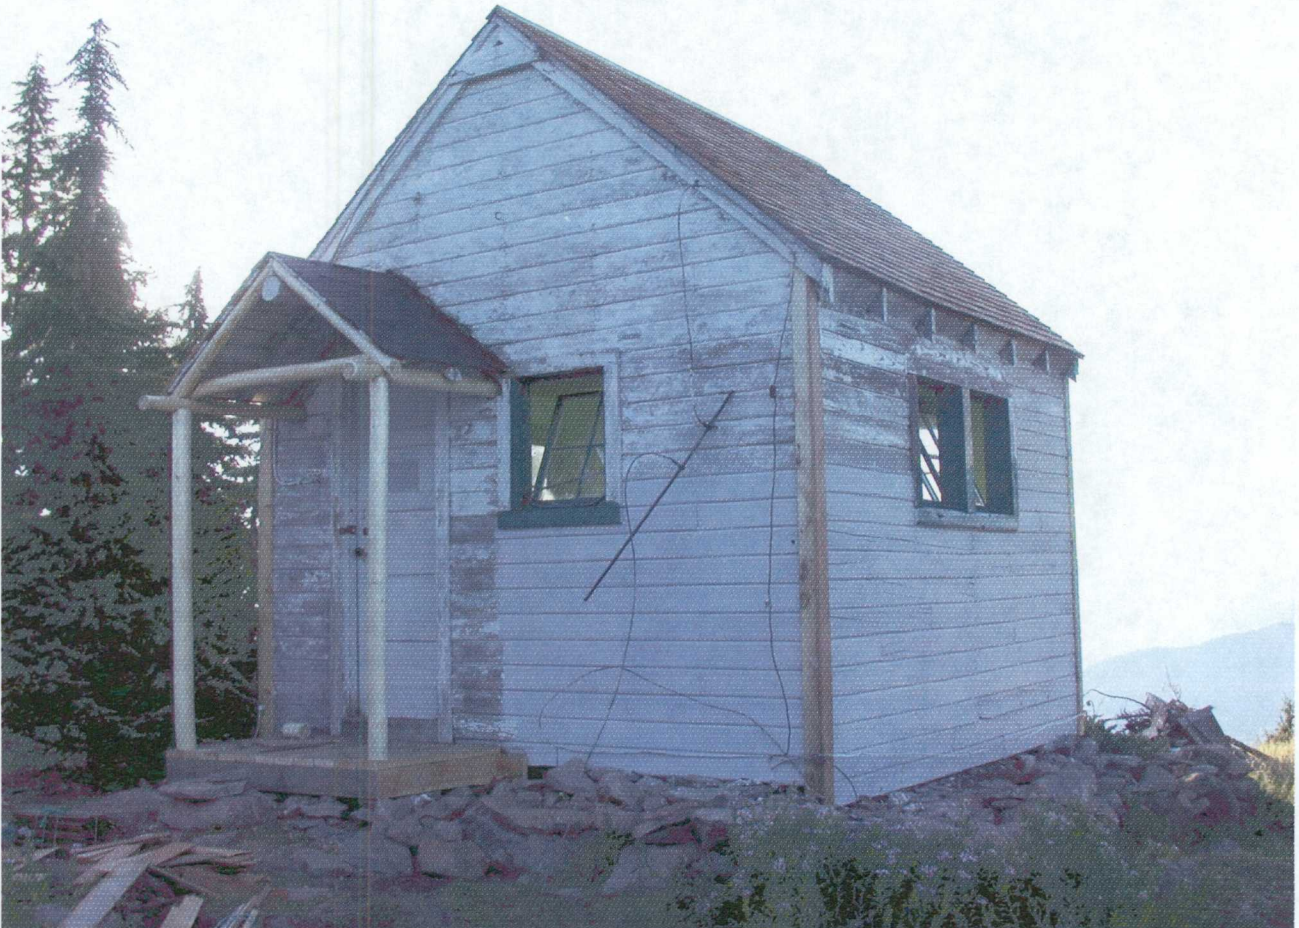
Corner Trim: The 1x4" trim boards at the four corners of the building were in various stages of deterioration. They were badly split, warped, or missing sections. In addition, it appeared that at some point in time the lower sections of full length trim boards had decayed and were cut off and replaced with short sections approximately two feet in length. The trim boards were removed entirely and replaced with new boards of full length.

Porch: Initial thinking was that one porch support would have to be replaced to return the sagging porch roof to its proper alignment. Upon closer inspection prior to restoration, it was discovered that there were more severe existing and potential problems. The 2x6" deck frame and several deck boards of the same dimension were broken and covered with a scrap piece of plywood to prevent falling through. It was determined that the entire deck would need to be rebuilt and leveled before a new log post could be installed to support the roof. The two wall ties which support the rafters, the two front rafters, and the crosstie between supports would also need replacement long before the new porch roof would need to be replaced again. To replace these peeled pole elements at a later date would involve removal of the new shingles and roof decking. Therefore, it was decided that all elements in doubt should be replaced prior to installing the new roof. Western redcedar poles were cut and peeled in late July (2002) in anticipation of what might be required.

Corner trim and porch repairs

After rigging a support to hold the main ridgepole and roof, almost the entire porch was disassembled. When the old deck and joists were removed it was discovered that a lower portion of the sill below the cabin door had some decay. After removing the decay, approximately two-thirds of the sill remained in good condition. Flat rocks were inserted to fill any voids before externally bridging this portion of the sill with the 2x6" face plate (which also serves as a joist for the decking). Following this, the remainder of the porch was framed matching the previous dimensions and decked with new 2x6" lumber. Instead of just one new support post, both support posts were installed along with the other pole structural members mentioned above. The roof boards were then replaced and covered with 15 pound roofing felt prior to installing the new shingles. Porch shingles were placed with a 4 inch exposure and capped at the ridge with cedar 1x4s. All components replaced on the porch match what was previously in place, both in materials and dimensions.

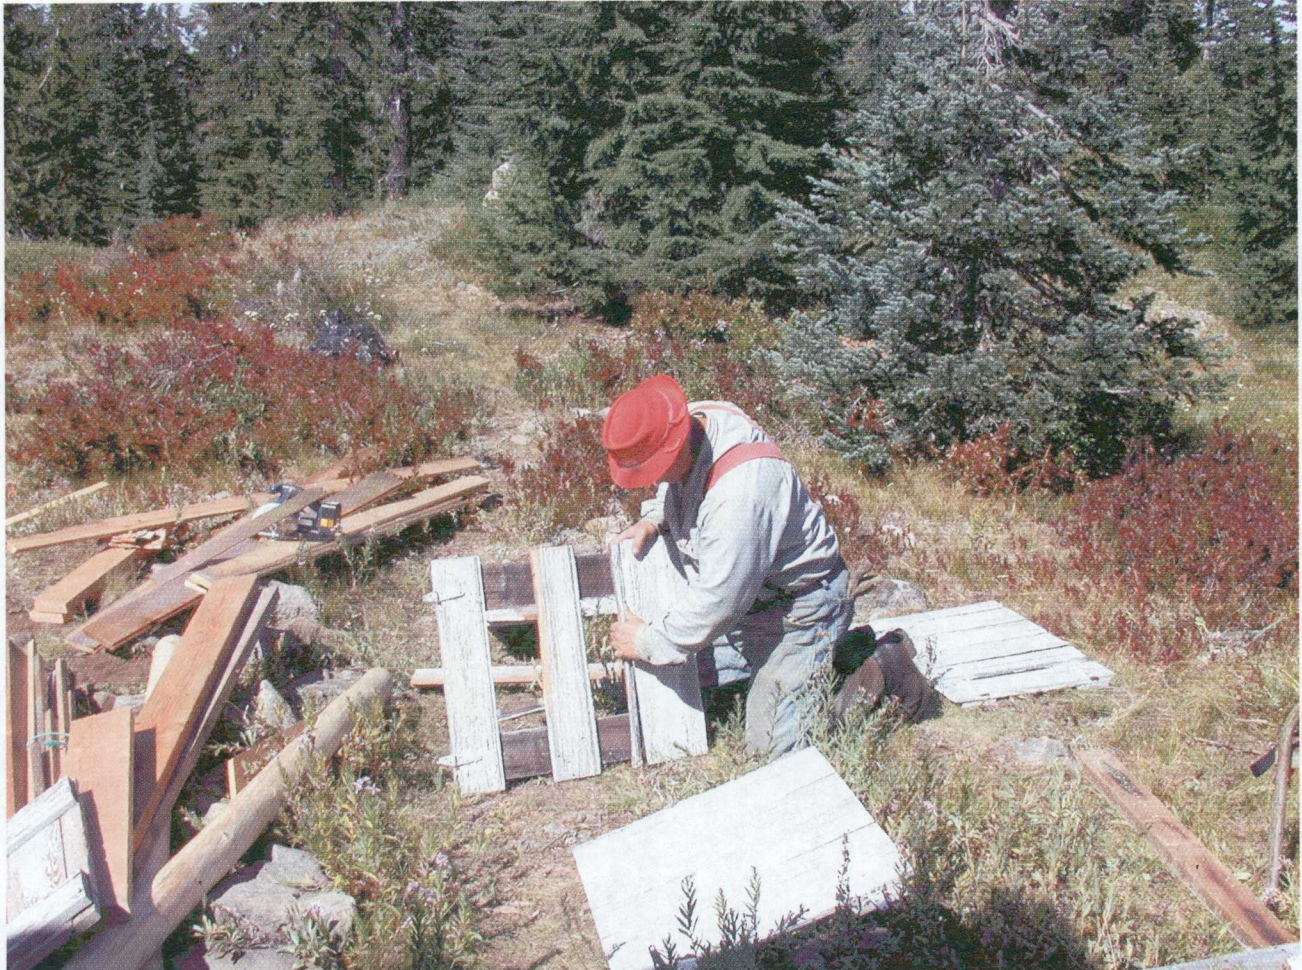
Storm Shutters: The storm shutters were in various stages of disrepair. Some had missing or broken hinges, and many had missing boards which allowed snow to build up inside the closed shutters. All shutters were removed for repairs. The missing shiplap boards were replaced and new hinges were installed where needed. They were then scraped and repainted before being reinstalled. New rotating fasteners were made of wood and installed above each window shutter to secure them in the closed position. New fasteners were not made to secure the storm shutter for the door but could easily be added at a later time.

Gary McCullough repairing storm shutters

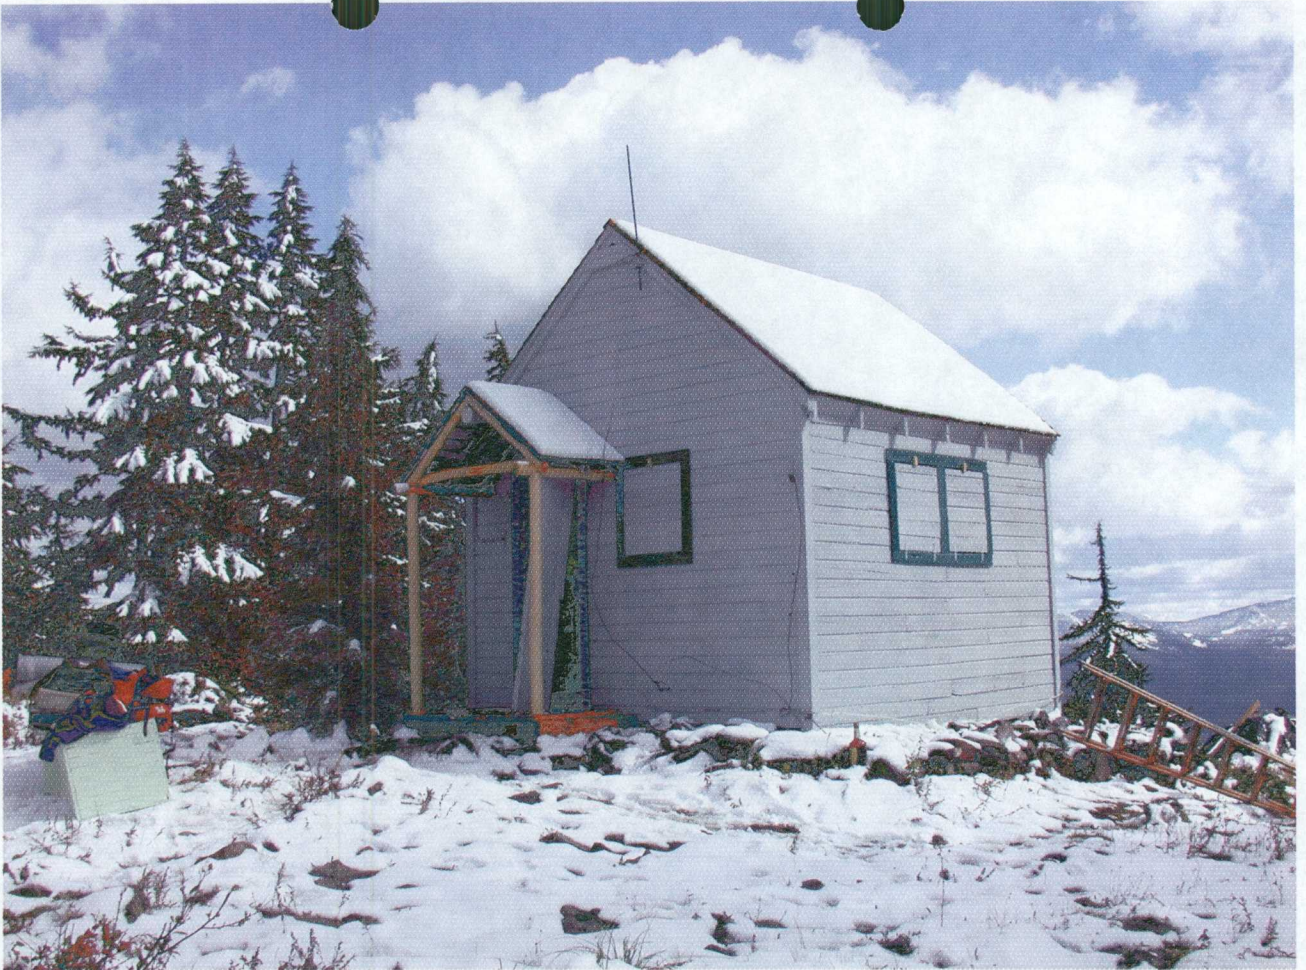
Ready for another winter
